CONTINUING ELIGIBILITY INSPECTION (CEI) REPORT**FOR FLOOD CONTROL PROJECT****Honolulu Engineer District****CEPOH-EC-T***Keopu FCP05rpt-fcp.doc*

1. Project Name: **Keōpū Stream Flood Control Project**

2. Date of Inspection: December 16, 2004

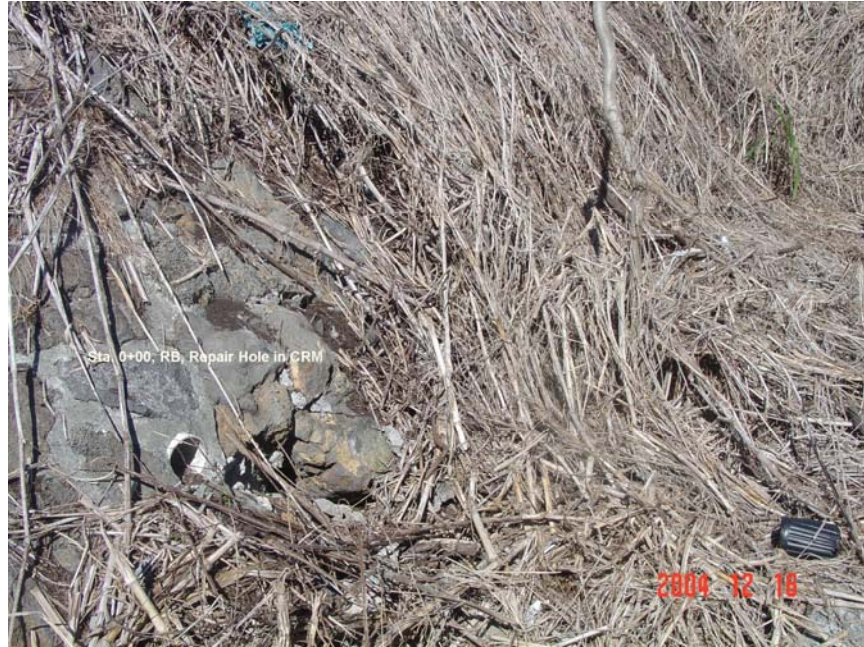
- a. Sta. 0+00, Right Bank (RB), repair hole in CRM sideslope.

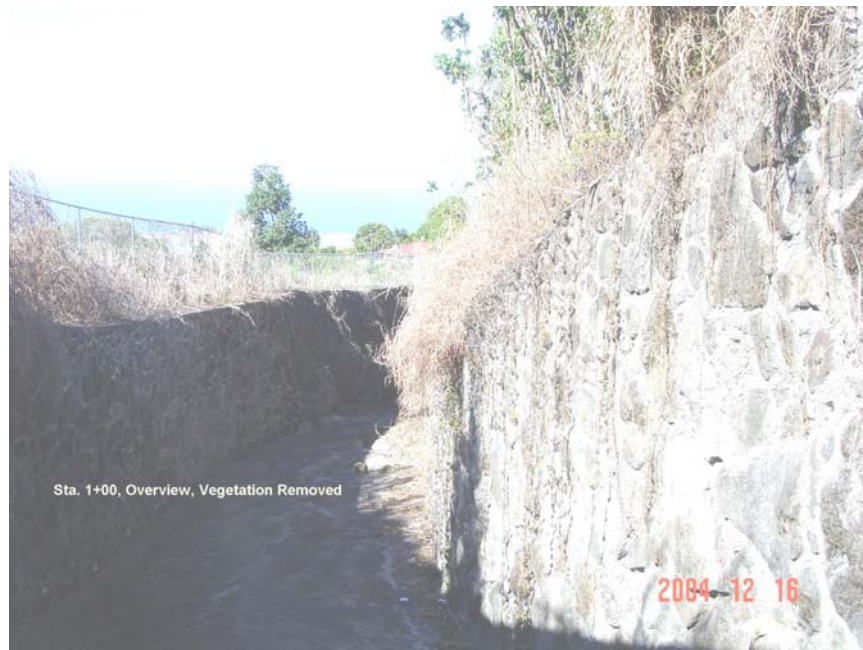
- c. Sta. 1+00, Left Bank (LB), continue to remove vegetation from sideslope.

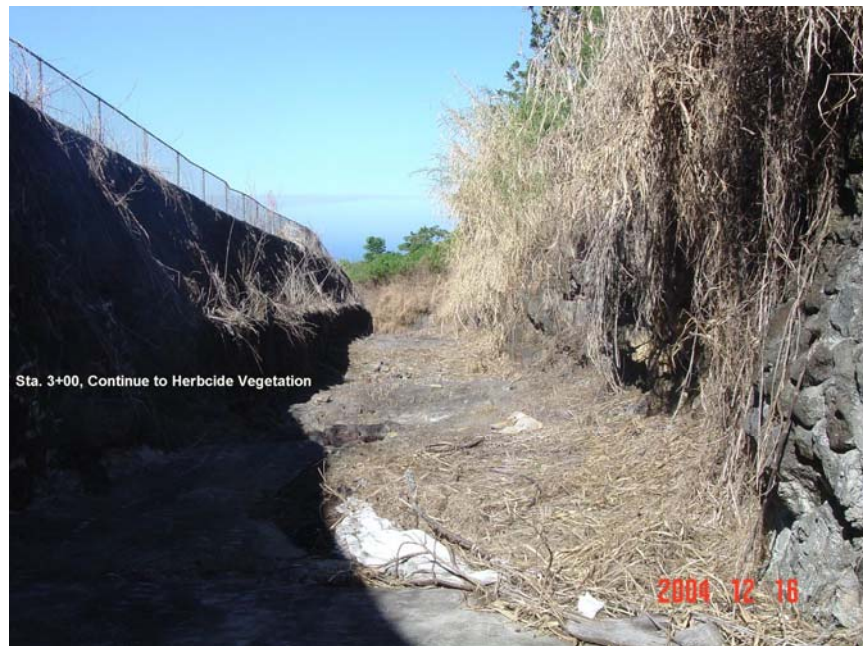
- d. Sta. 3+00, Typical of channel vegetation to be removed.

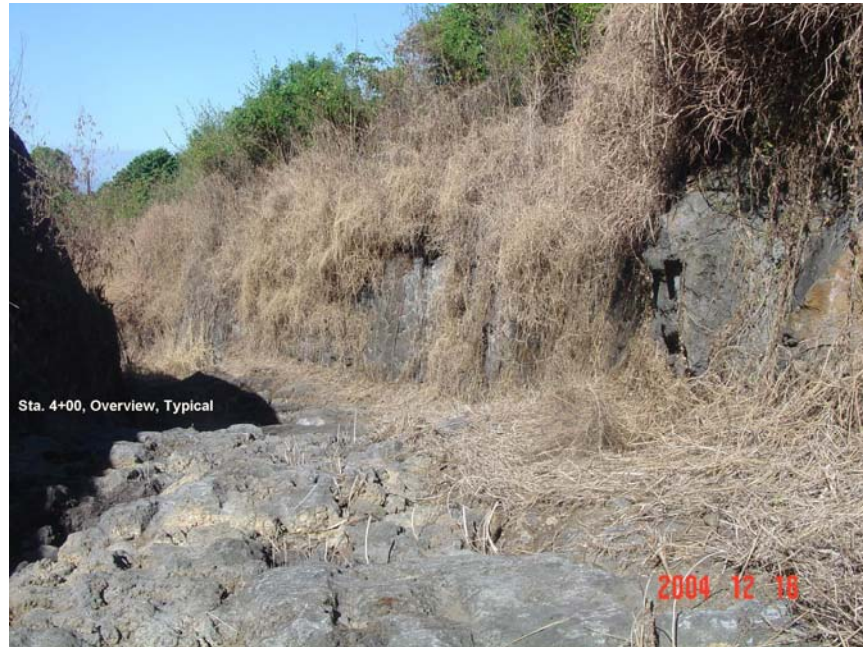
- e. Typical of channel vegetation to be removed.

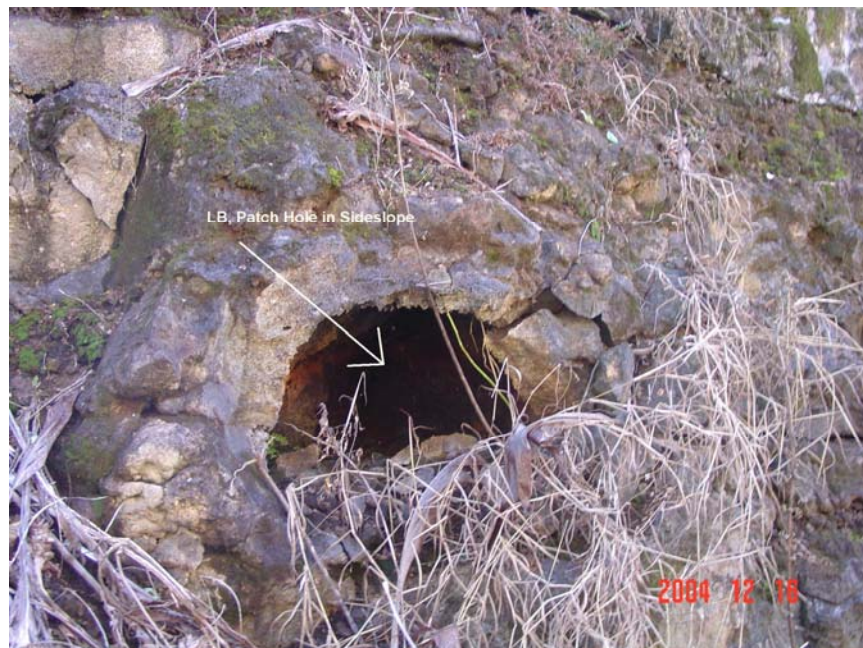
- f. LB, fill hole in sideslope.

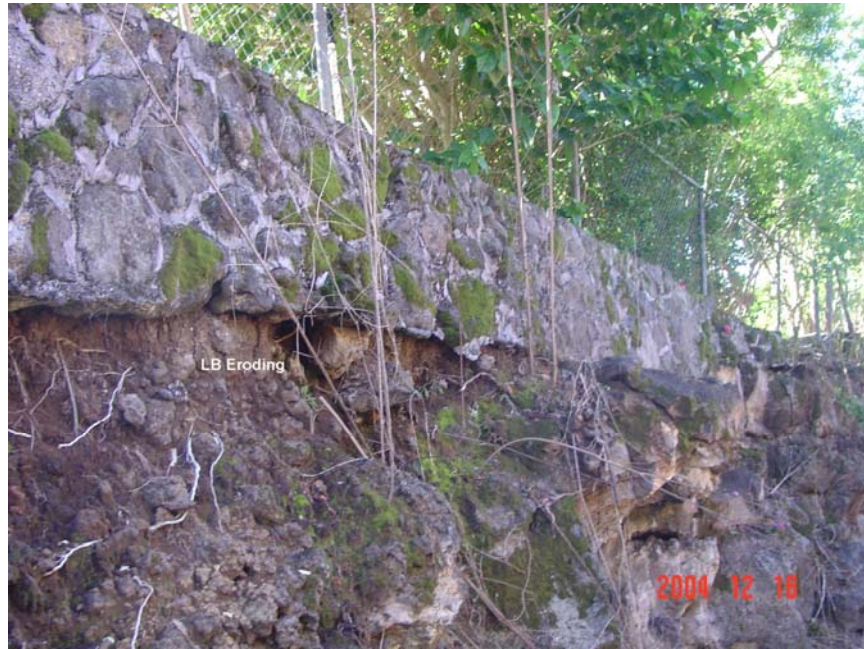
- g. LB, monitor and repair eroding channel side as needed.

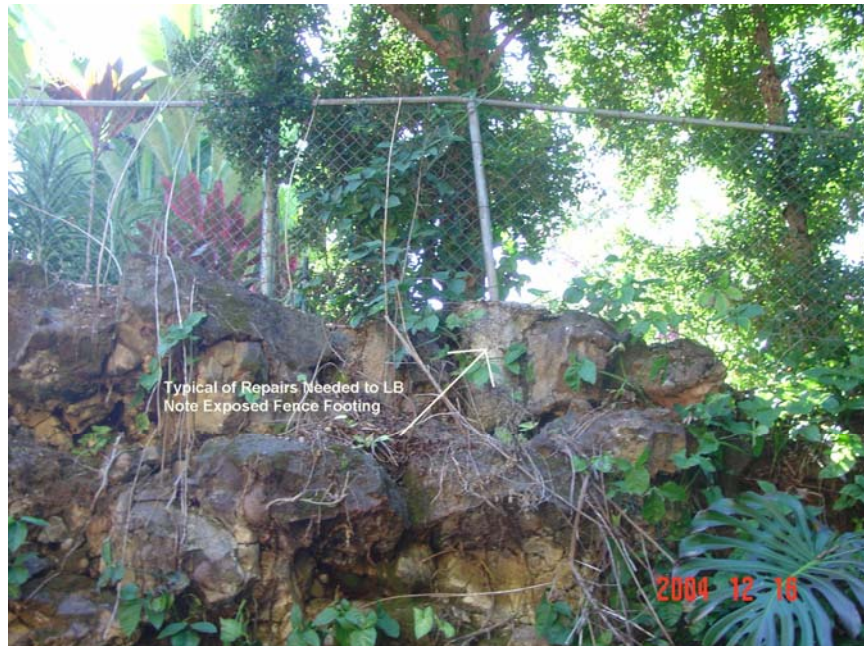
- h. Typical of sideslope erosion, exposed fence post footings and channel vegetation to be removed, sideslope to be repaired.

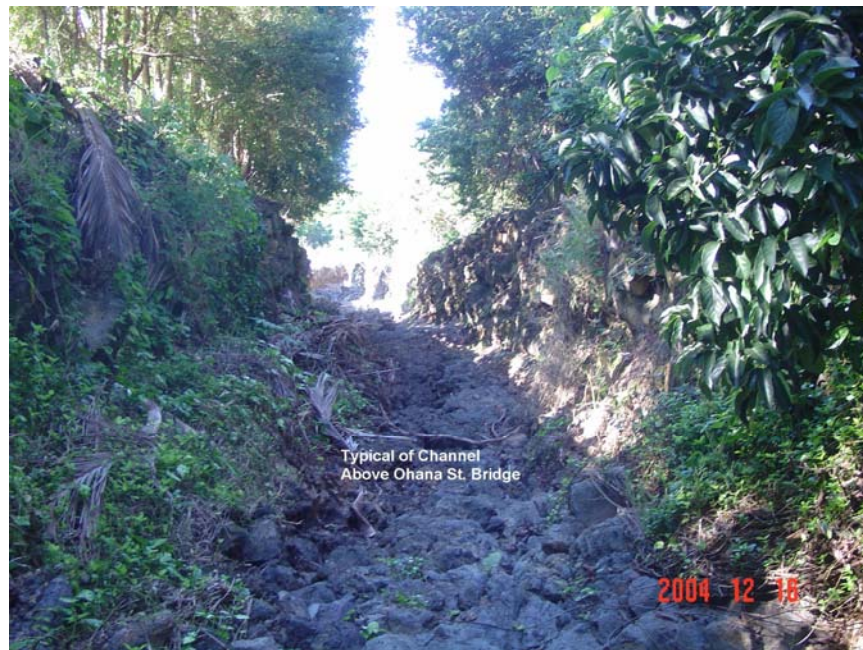
- i. Overview of channel above Ohana St. Bridge

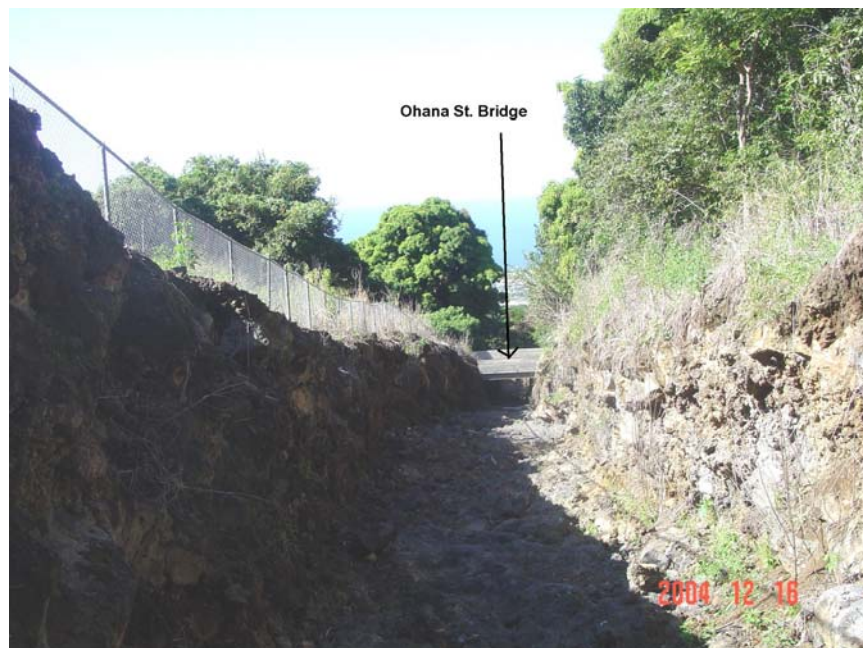
- j. Typical of channel vegetation to be removed above Ohana Rd. Bridge.

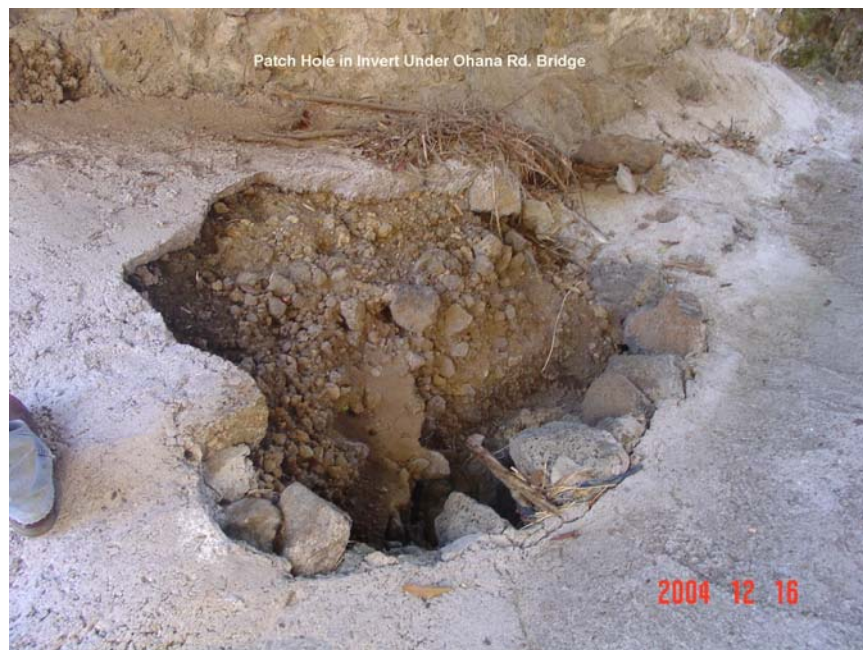
k.. Repair invert hole under Ohana St. Bridge.

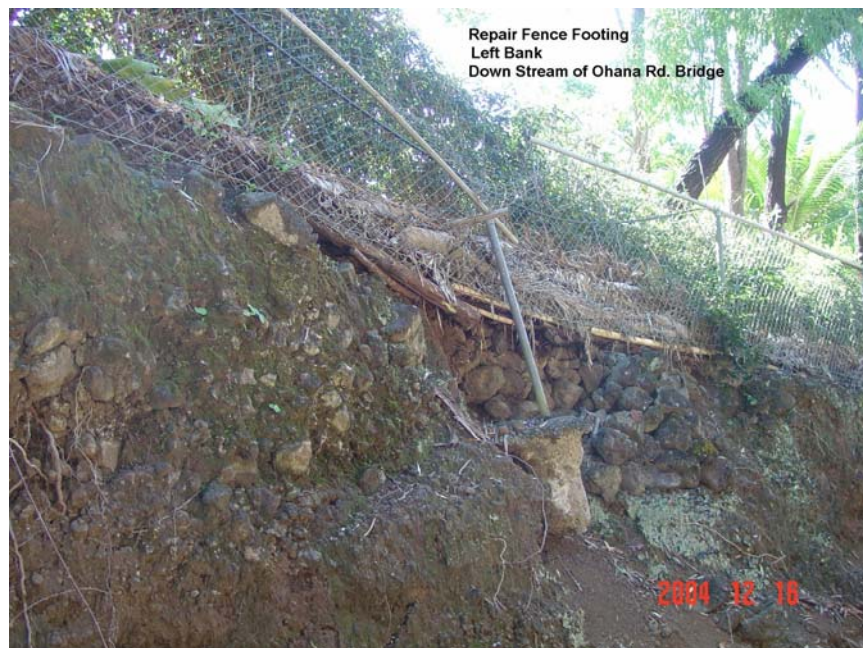
l. Typical of sideslope erosion, exposed fence post footings and channel vegetation to be removed sideslope to be repaired.

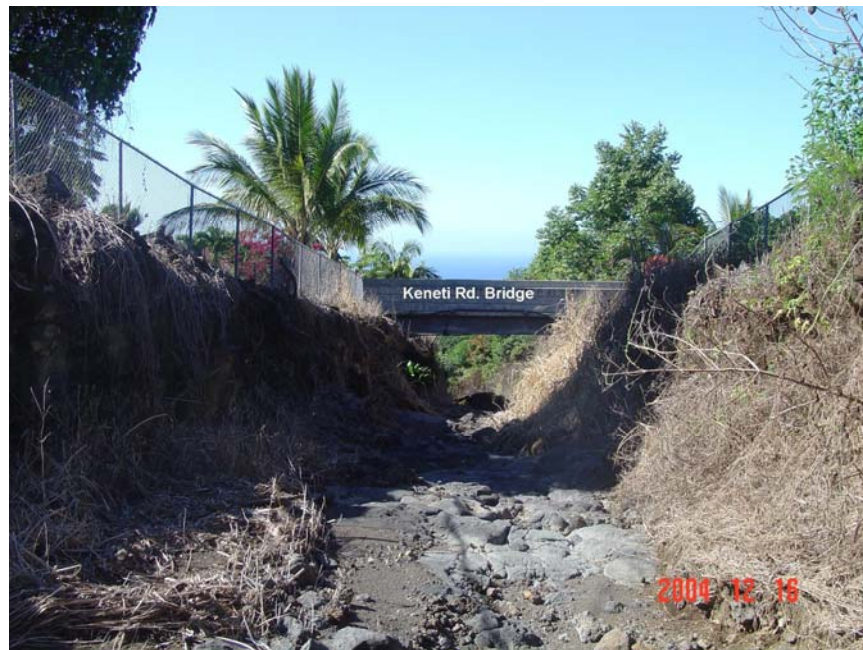
m. Typical of channel vegetation to be removed, at Keneti Rd. Bridge.

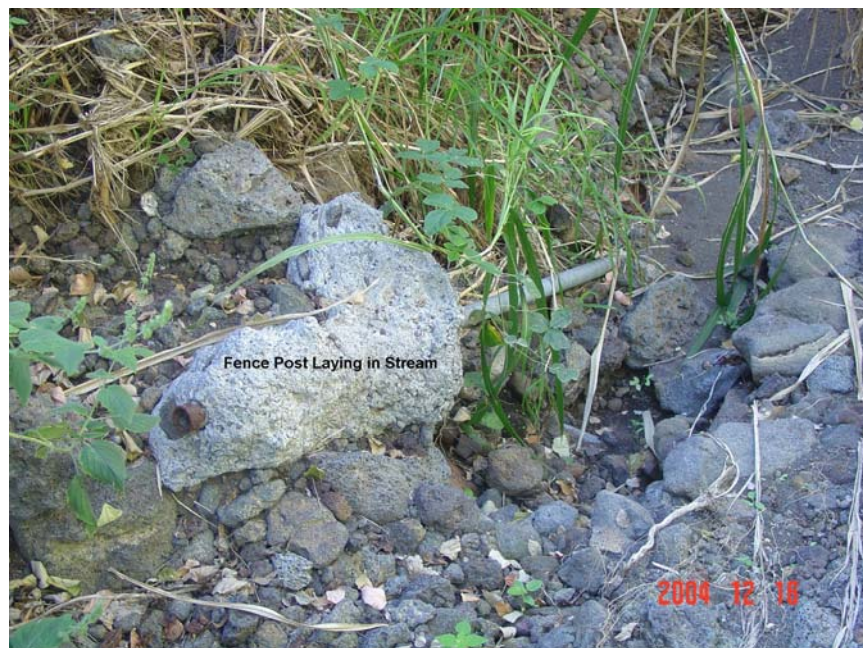
n. Determine source of eroded fence post and replace.

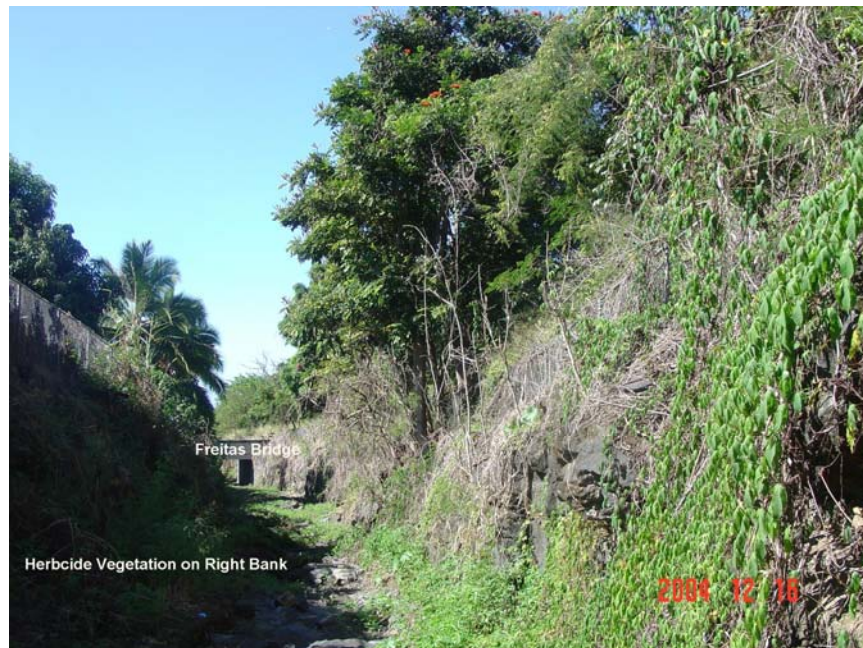
o. Typical of channel vegetation to be removed.

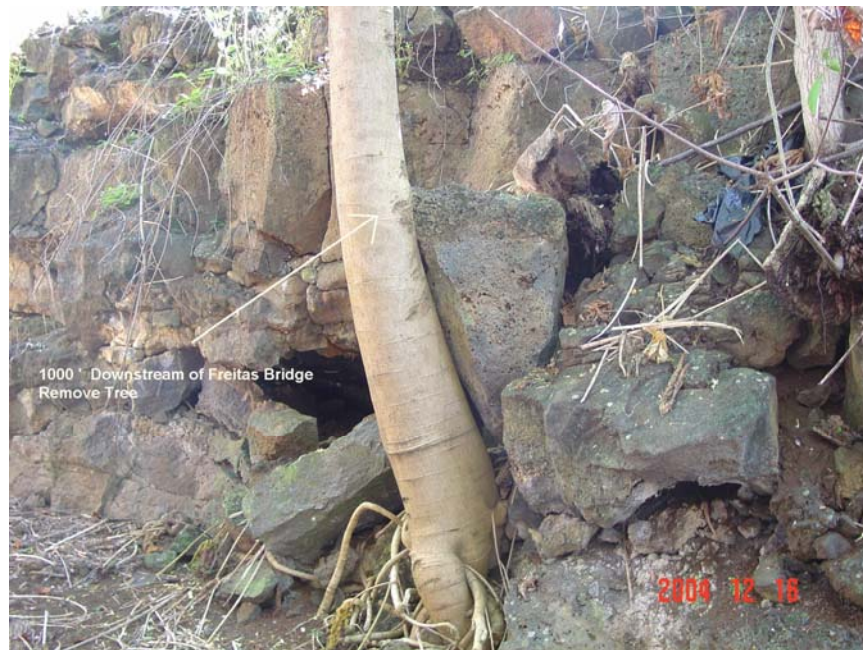
- q. Remove tree from base of channel, RB, approx. 1000 lf downstream of Freitas St. Bridge.

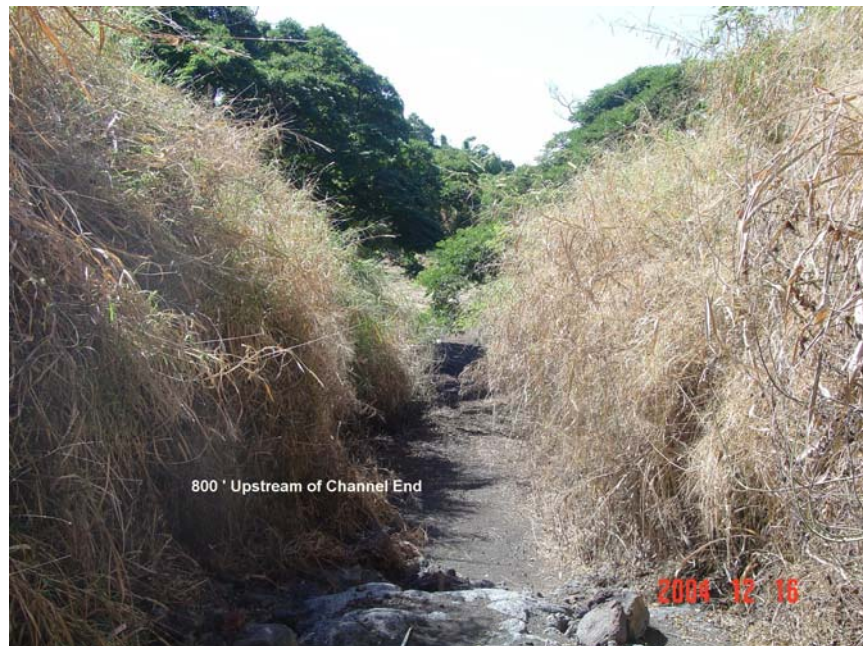
- r. Overview, 800 lf upstream of end of channel, clear vegetation.

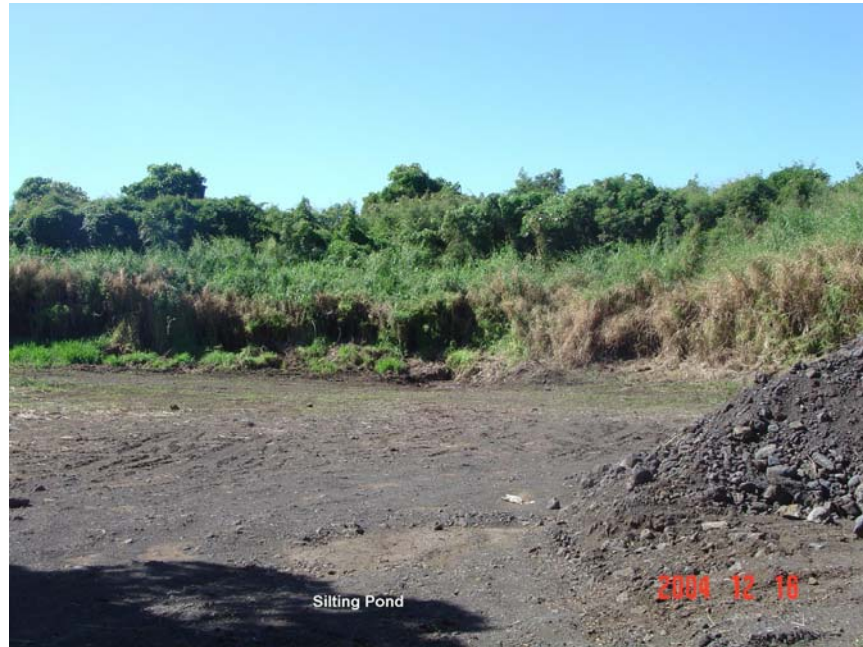
- s. Overview of Silting Pond, good maintenance.

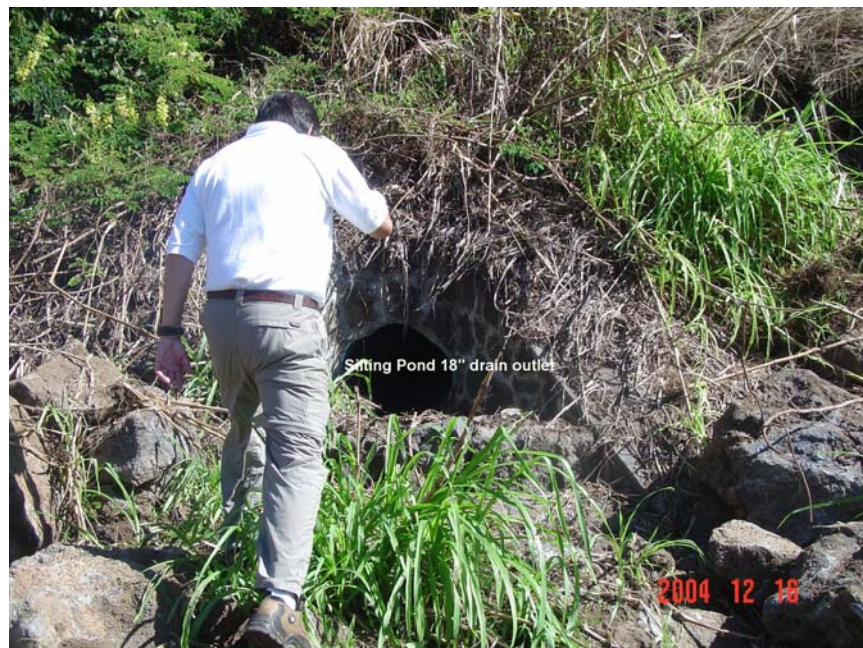
- t. Continue to maintain 18" drain from Silting Pond.
